MARINE CASUALTY REPORT

SS OGDEN WILLAMETTE: MAJOR ENGINE ROOM FLOODING

MARINE BOARD OF INVESTIGATION REPORT

REPORT NO. USCG 16732/0210

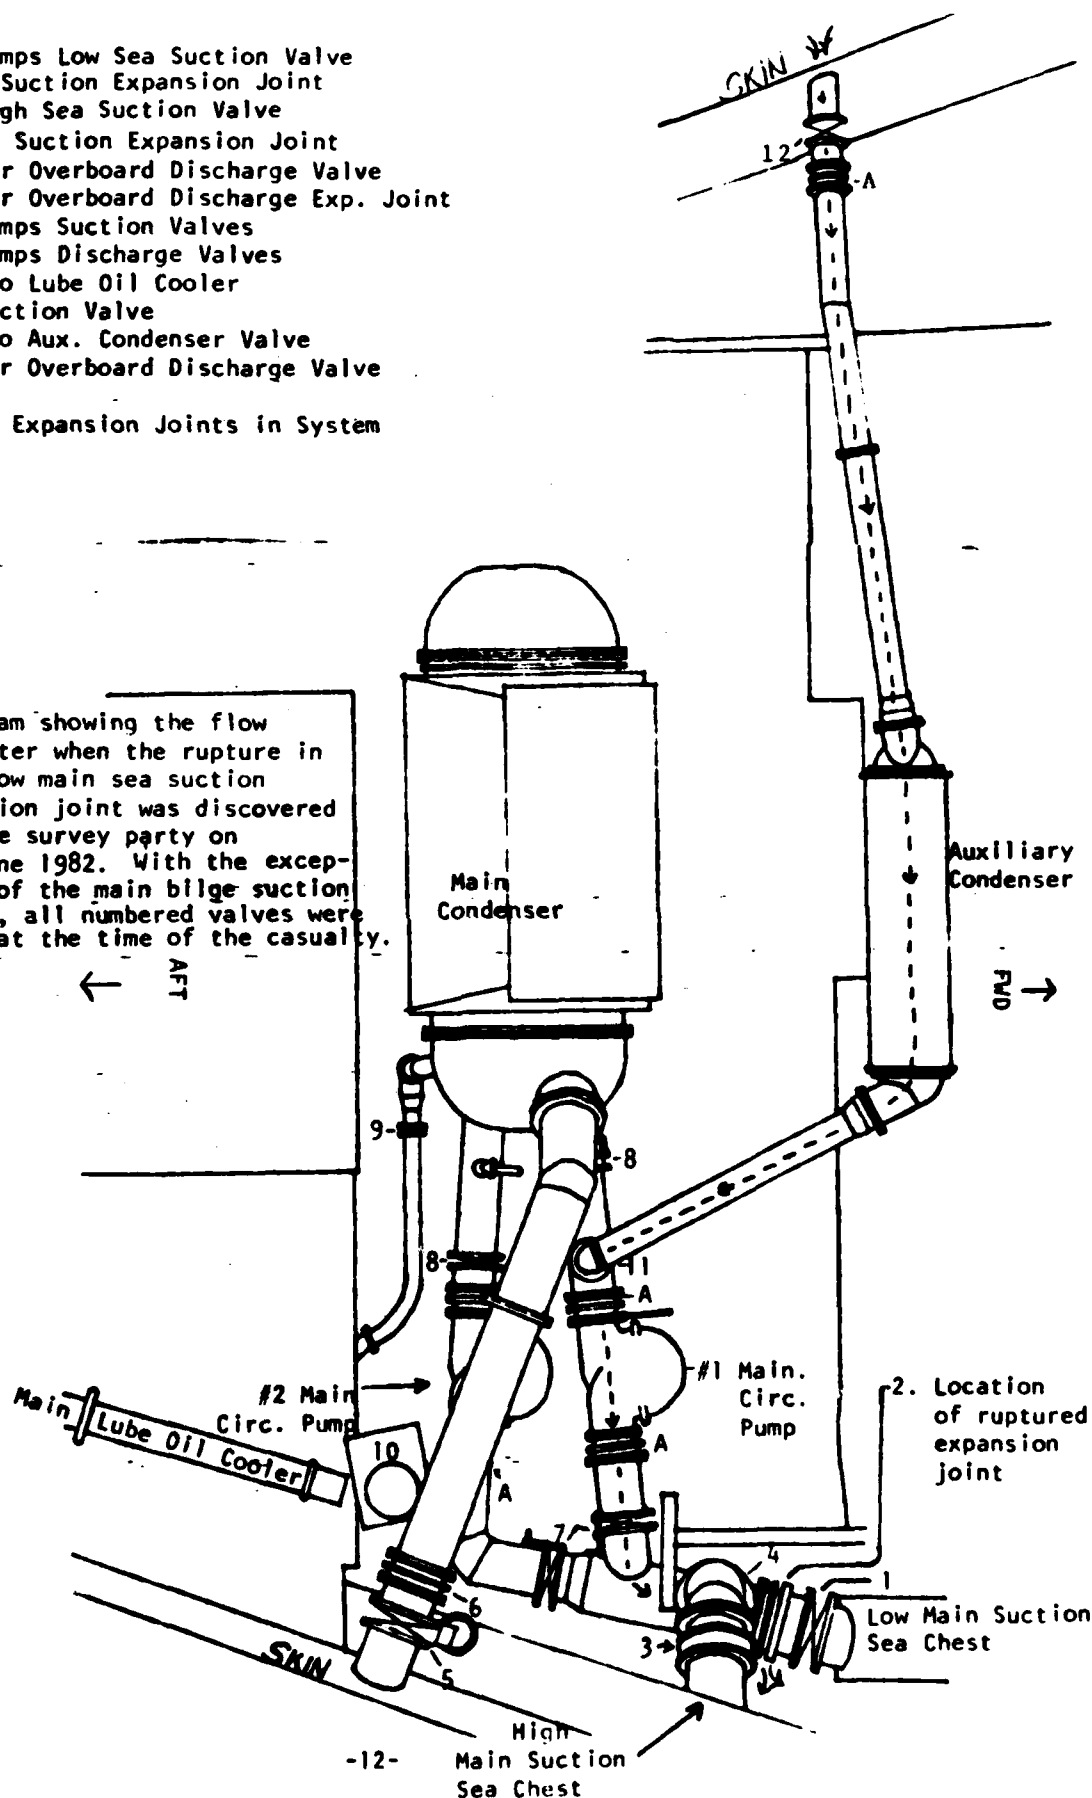
Figure 1. Diagram showing the flow of water when the rupture in the low main sea suction expansion joint was discovered by the survey party on 29 June 1982. With the exception of the main bilge suction valve, all numbered valves were open at the time of the casualty.
